Application of GUT Matrix in the assessment of pathological manifestations in heritage constructions

The present paper presents the application of GUT (Gravity, Urgency, Tendency) Matrix methodology as a tool in the assessment of pathological manifestations in buildings. Three heritage constructions of the historic center of Sobral, Ceará, Brazil were studied through *in situ* inspections, photographic records and elaboration of the damage map. The GUT Matrix was used as a tool to rank, in each building, priority levels for each damage in order to define their order of treatment. Thus, it was possible to conclude that the applied method can be used as a useful tool to manage the maintenance of buildings through prioritization of the most significant problems and, to contribute directly to the preservation and safety of the built historical heritage.

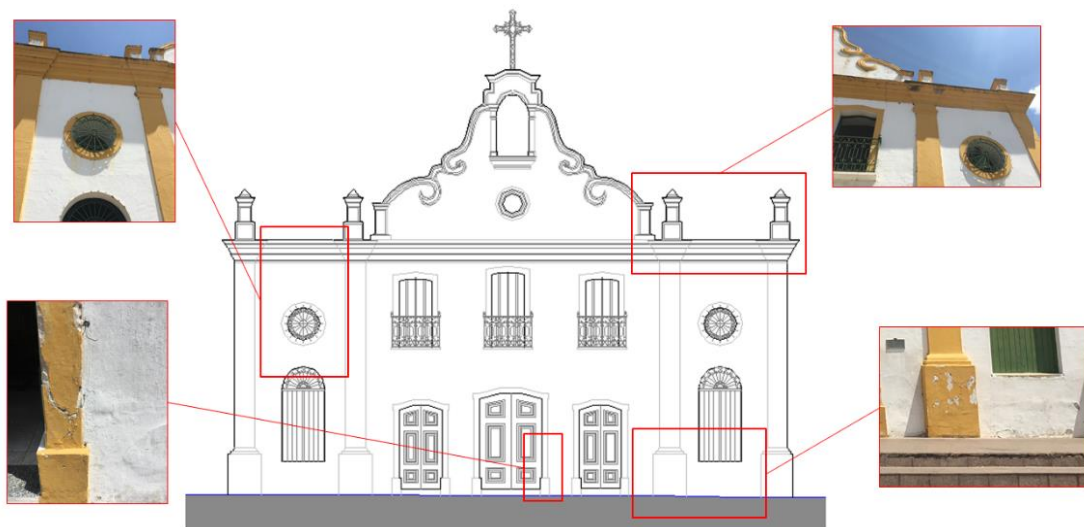
identification of the damage of the structures. Moreover, combining the visual inspection with other control tools, as presented in this work through the GUT Matrix, enriches the results and contributes to their reliability. The inspection of this first church was carried out from the outside to the inside, where firstly the four facades and later the interior were inspected. During inspection the following pathological manifestations were identified: fissures and cracks, disintegration of lining elements, detachment of coating, humidity stains, atmospheric stains, mold/mildew. The main facade presented the biggest number of damages and it is represented by the damage map shown in Figure 4, where detachments are observed in the lower parts of the structure, in the openings and in the central door column some cracks are also visualized, and atmospheric stains can be seen on the top of the church.

The main reason for cracking may be associated with the vibrations existing in the place, because it is located in a central region of the Sobral city and there is a large flow of people and vehicles nearby, that can induce vibrations causing changes in the structure dynamic behavior, which often lead to fissures.

Figure 4. Damage map of the main facade of Nossa Senhora do Rosário Church.

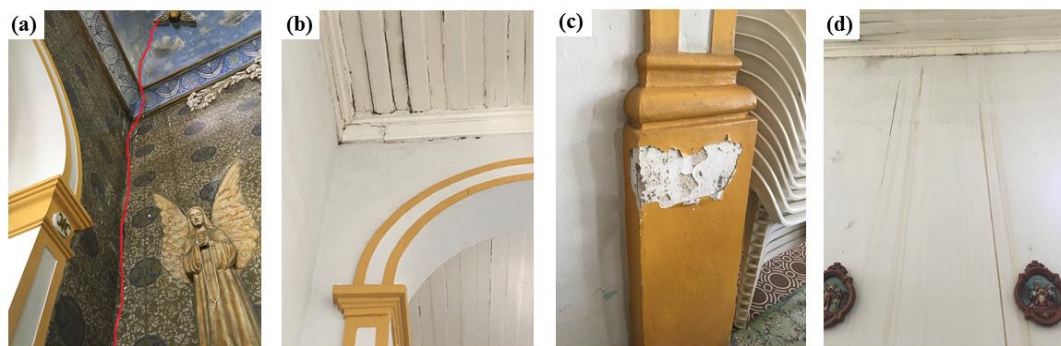
Figure 5. Internal pathological manifestations of the Nossa Senhora do Rosário Church: (a) crack, (b) disintegration of lining elements, (c) detachment and (d) humidity stains.

In the internal part of the church the main, the following pathological manifestations were observed: crack, disintegration of lining elements, detachments and humidity stains, as illustrated by the Figure 5. The most serious situation was the crack located near the altar (Figure 5 (a)), because its presence may be associated with the movements adjacent to the building and new constructions in the vicinity of the sanctuary. These movements occasionally cause sinking of the soil and cracks and fissures in

For the Gravity in the application of the GUT methodology a score 8 was attributed to the crack located near the altar due its large opening. For the Urgency, a score 8 was also inserted due large area of commitment of this damage that requires urgent intervention. Regarding Tendency, a score 6 is attributed knowing that the problem is in a situation of average progression.

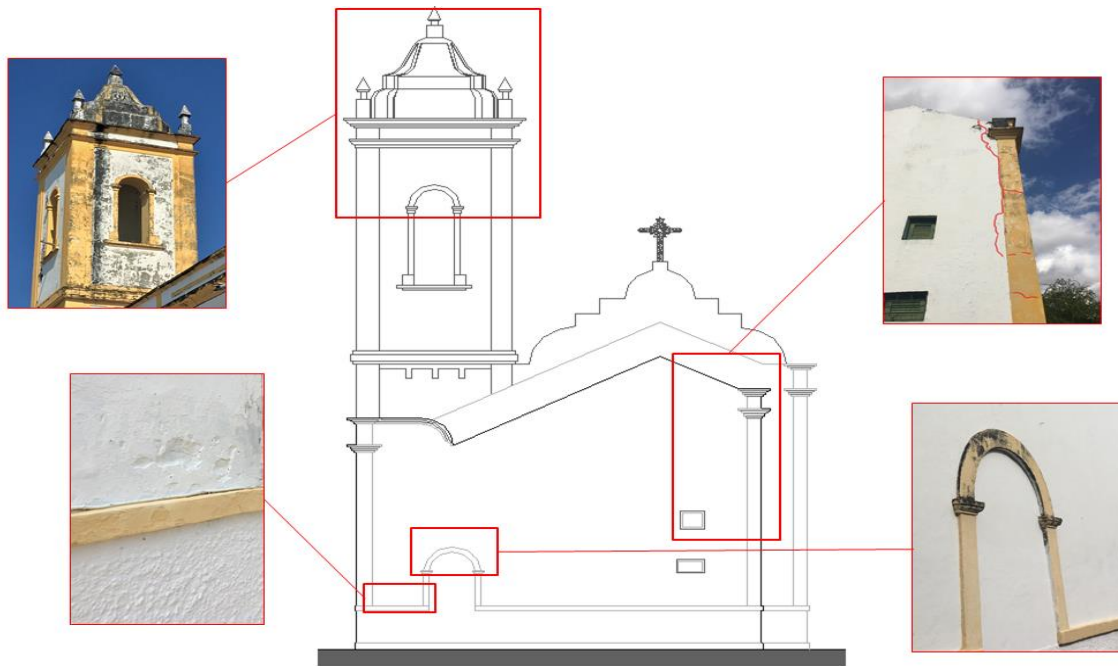
Figure 7. Damage map of the Nossa Senhora das Dores Church.

Figure 7 shows the incidence of a large amount of atmospheric stains in the lateral tower and also in the upper parts of the church. This type of damage was also evident in all other facades. A large crack in the right part of this figure, that starts from the mid height of the wall to the top, was observed. This anomaly is closely linked to a possible sinking of the soil, considering that the structure is located near of the Acaraú River and that over time was impacted by numerous new constructions in the vicinity. Besides this region, in the circular openings of the other facades, this type of damage is also evidenced. There are also detachments of coating in the lower part of this facade, which are also found in the other facades.

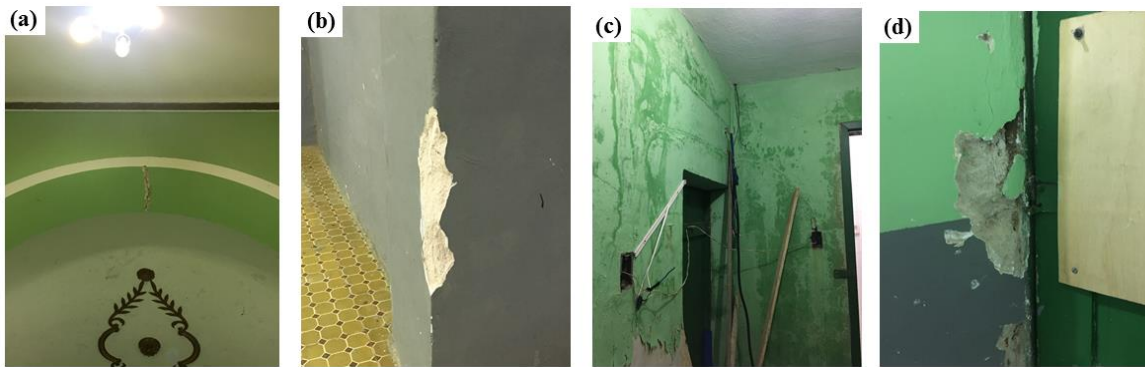
The main pathological manifestations observed in the internal part of the structure were: fissures and cracks, detachment of coating, humidity stains and detachment of coating with exposure of parts of the frame, which are illustrated in Figure 8. In Figure 8 (a), there is the most severe pathological manifestation for this building: a crack located in the central arch of the main nave. This anomaly is in a very aggravated situation, being its occurrence related to the incidence of soil movement of the foundation and to a possible overload in the arch, since many interventions with an increase of load were executed over time, as for example, the exchange of a lining that was previously made of PVC by a slab of reinforced concrete. Thus, to Gravity, a score 10 was attributed, that is, the maximum score of the method here used, which causes a high impairment of the performance of the building. Regarding Urgency, a score 10 was also inserted, due to the large area of commitment of this manifestation, requiring urgent intervention. And for Tendency it was also chosen a score 10, corresponding to the large possibility of evolution of the situation.

Figure 8. Internal pathological manifestations of the Nossa Senhora das Dores Church: (a) crack in the central arch, (b) detachment of coating, (c) humidity stains and (d) detachment of coating with exposure of the frame parts.

The data obtained from the application of the GUT Matrix in this building were organized in the priority graph shown in Figure 9, where it is verified that the pathological manifestation of highest priority is the crack in the central arch of the main nave, with a total of 1000 scores, which classifies it as a total damage, that is, of extreme gravity, urgency of solution and fast tendency of evolution. In addition, the difference between this damage and the two other (infiltration and disintegration of lining elements, both with 216 scores each) is very high, that corresponds to 784 scores, which show the severity of this crack.

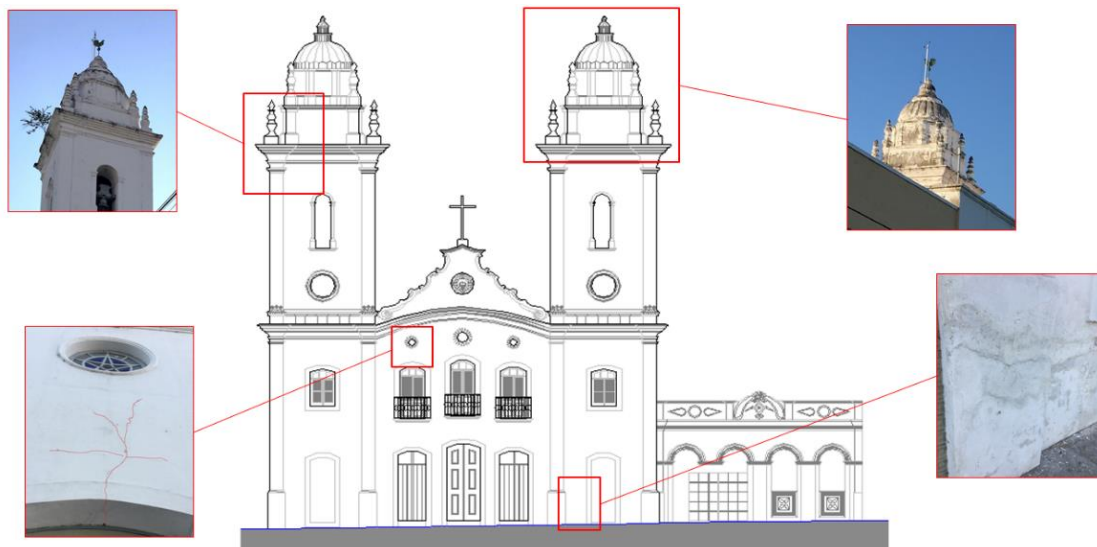
The right lateral facade (connected to the lateral courtyard) and the back facade of the Menino Deus Church were not analyzed because these two facades are linked to the adjacent buildings. However, the other facades as well the internal area were thoroughly inspected, and the main facade presented the most severe damages, which can be observed in Figure 10, where the most evident were: atmospheric stains, located in many regions of the structure mainly on top of the two towers; fissures in the vicinity of circular openings of all doors and windows and in the lower part the columns of a tower, which is accompanied by detachment of coating; and rooting of shrubs, located at the top of the left lateral tower.

Figure 10. Pathological manifestations of the Menino Deus Church.

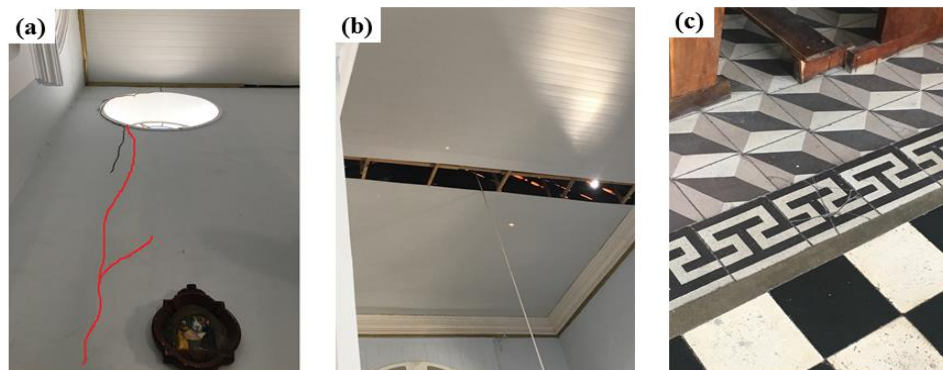
In the internal part of the church the main damages observed were fissures and cracks, disintegration of lining elements and disintegration of floor elements, as shown in Figure 11. Disintegration of lining elements was observed in many parts of the roof, as well as fissures.

Figure 11. Pathological manifestations in the internal part of the Menino Deus Church: (a) Fissures, (b) disintegration of lining elements and (c) disaggregation of floor elements.
