Engineering Failure Analysis 10 (2003) 423–429

Fracture analysis of a flow control device used in the petrochemical industry

This paper presents a service failure analysis of a steel control device assembled in a petrochemical industry division which resulted in a great fire. The purpose of this analysis was the determination of the reasons that caused fractures in the fixation screws of the body/cover of the valve during operation. The failure caused the leakage of hydrogen (H₂) and sulfide gas (H₂S), being responsible for an accident in Fortaleza, Brazil. Techniques such as visual inspection, electronic microscopy, optical microscopy, determination of mechanical properties, design analysis by computational simulation and spectrometry were used in this investigation. Several factors influenced the failure mechanism, such as: design failure, environmental cracking, device components out of fatigue and fracture specifications.

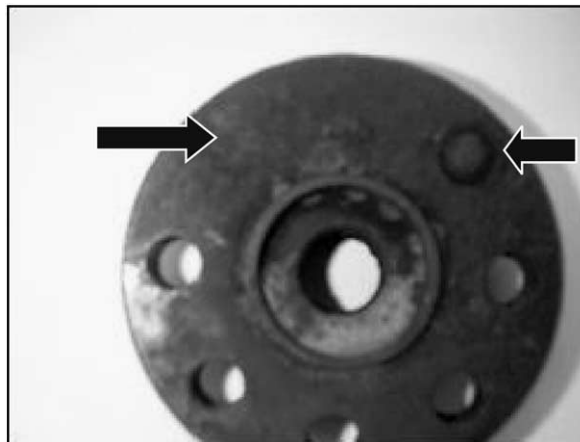
Superficial corrosion was observed on the first two fractured screws on the flange (see Fig. 1). The rupture initiated at these two screws.

Fig. 1. The arrows show the superficial corrosion of the first two fractured screws.

In the visual inspection of the flange, surface corrosion was evident (see Fig. 1). The corrosion also happened in other components of the valve.

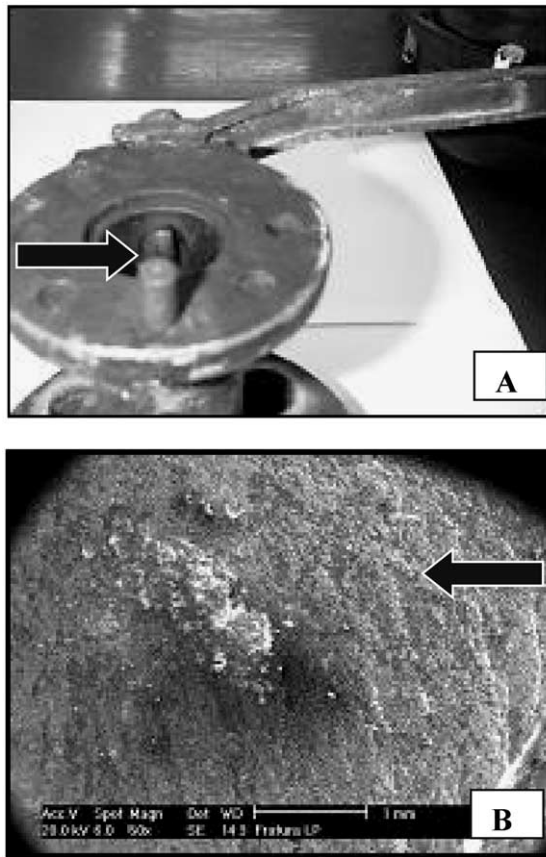
Fig. 2. (a) Fractured screw that remaining fixed on the valve. (b) Striations observed at the top of the fixed fractured screw in the valve flange.

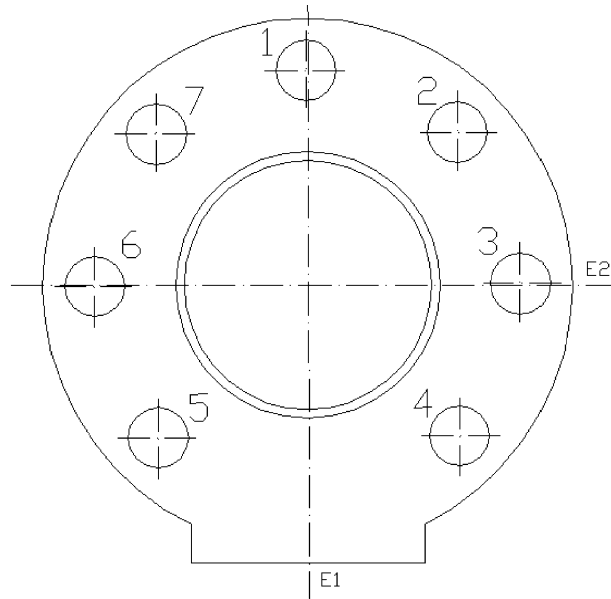
Fig. 3. Flange surface drawn with the screw holes numerically identified.

It was also observed, that the flange holes possess a pattern that contributed to an irregular stress distribution. The flange did not present symmetry in relation to axis E1 (see Fig. 3). This irregular stress distribution contributed to cause an overload in screws 4 and 5 (see Fig. 3), as the computational simulation shows (see Fig. 8).

The valve failed first by environmental cracking in screws 4 and 5 (see Fig. 3), promoted by the flange screws pattern, hostile environment and use of screws out of specification. Later, fatigue crack propagation caused gas leakage from the valve with the loss of screws 4 and 5, consequently, cyclic loads in the remaining screws led to the failure. The use of inadequate material diminished screw life. Finally, the main causes that had contributed to the failure were: the design of the valve that allowed an irregular stress distribution in the screws, overloading screws 4 and 5; use of screws out of specification that led to environmental cracking (inadequate composition and high hardness) and reduction of fatigue life.

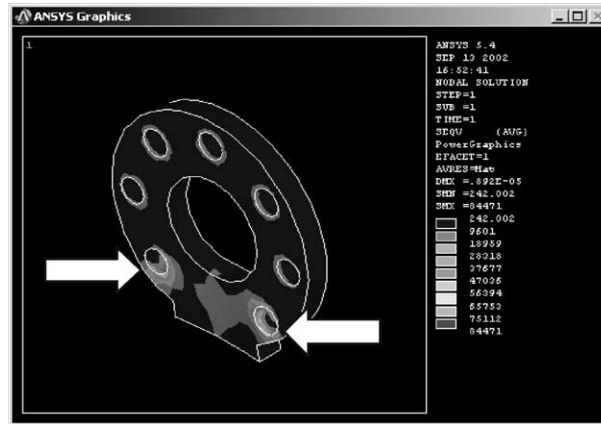
Fig. 8. Von Mises Stress contour plot. The arrows point to the stress concentrations caused by the non-symmetry of screw positions.

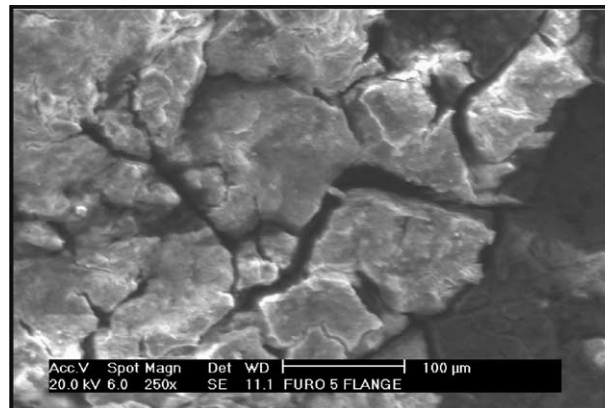
According to JONES [3], intergranular crack propagation usually shows grain boundary facets free of ductility (see Fig. 9).

Chemical analysis of the screw showed that molybdenum composition was less than the values specified for ASTM A 193/A 193 M-86 [4]. Annealing should be done right after quenching to remove residual stresses. Residual stresses originated in Martensite formation (on quenching) had probably encouraged cracks. Cyclic loads like pressure oscillations on the plant had contributed to fatigue crack propagation. The analyzed values of the hardness were above the specified ones for ASTM A 193/A 193 M-86 [4] and the hardness reduction is a consequence of annealing that increases material toughness. The screws used for fixing the flanges were not in accordance with ASTM A 193/A 193 M-86 [4].

Fig. 9. Grain boundary facets free of ductility caused by environmental cracking.
