## Vulnerability assessment of Massaguaçu Beach (SE Brazil)

Paulo H.G.O. Sousa\*, Eduardo Siegle, Moysés Gonzalez Tessler

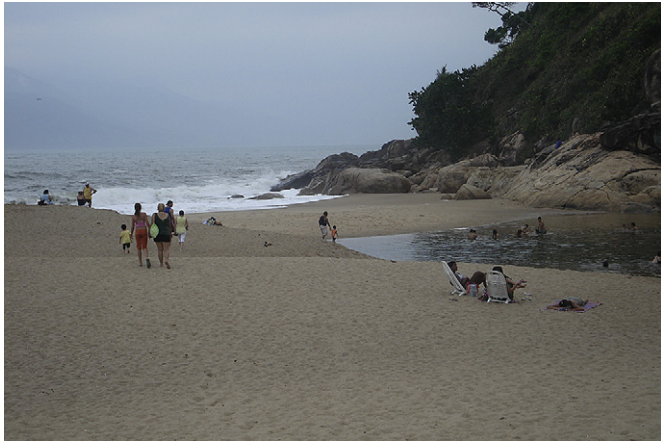
Fig. 4. The closed Capricórnio river inlet.

The Capricórnio river inlet is closed most of the time and channel flows have no competence to remove the sand that block the channel (Fig. 4). The opening of the channel occurs only during high wave energy events, when a storm surge results in sand

barrier overwash, creating a connecting channel that lasts for short periods only. Channel flows during the openings are not able to balance wave energy, resulting in channel closure shortly after the storms. There is also no indication of inlet migration during these short openings; the inlet is anchored by a rocky headland to the south and the adjacent river banks are well established and fixed by vegetation.

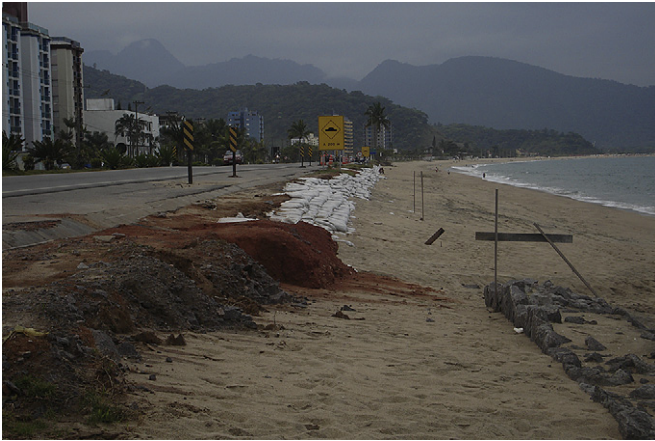
Fig. 6. Coastal engineering structures in Sector 2 (2006).

Another singularity of this sector is the presence of the Rio-Santos highway that runs close and parallel to the shoreline. Under stormy conditions the waves undermine the road basis affecting the highway. Such periods are critical, since the absence of sandbars allows waves to reach the shore with high energy levels. Aiming the protection of the road, coastal engineering structures were built along part of Sector 2 (Fig. 6). However, this seawall proved not to be effective since the waves rapidly caused its destruction and still reach and damage the road. The beach morphology presents a narrow profile, with an average width of about 50 m, including stretches with less than 10 m. There are no rivers/inlets reaching the region and no direct sediment sources available in this sector. Vegetation is scarce, representing only 0.4% of the studied perimeter. Although the area is densely occupied, with the exception of the highway, streets are not paved.
