Application of GUT Matrix in the assessment of pathological manifestations in heritage constructions

The present paper presents the application of GUT (Gravity, Urgency, Tendency) Matrix methodology as a tool in the assessment of pathological manifestations in buildings. Three heritage constructions of the historic center of Sobral, Ceará, Brazil were studied through *in situ* inspections, photographic records and elaboration of the damage map. The GUT Matrix was used as a tool to rank, in each building, priority levels for each damage in order to define their order of treatment. Thus, it was possible to conclude that the applied method can be used as a useful tool to manage the maintenance of buildings through prioritization of the most significant problems and, to contribute directly to the preservation and safety of the built historical heritage.

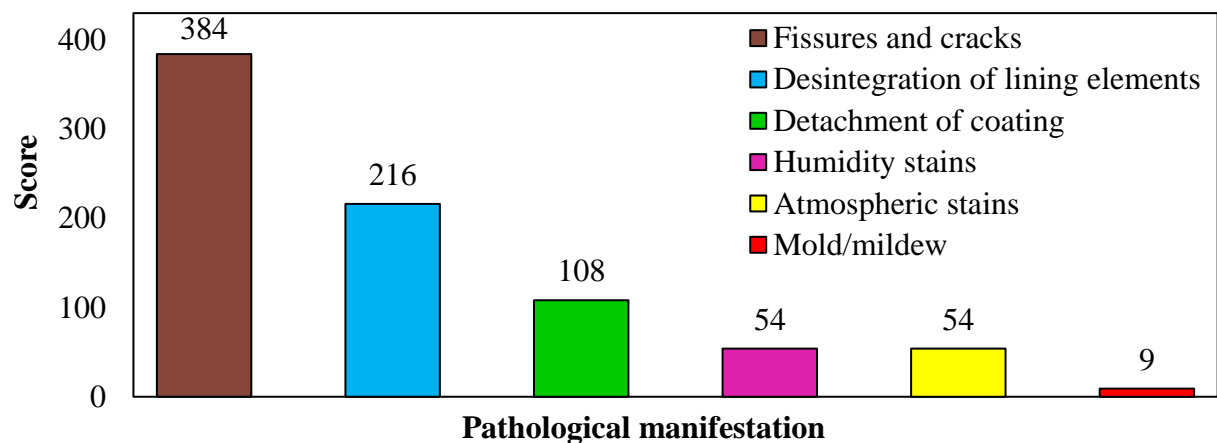
Figure 6. Priority graphic of the Nossa Senhora do Rosário Church.

For the Gravity in the application of the GUT methodology a score 8 was attributed to the crack located near the altar due its large opening. For the Urgency, a score 8 was also inserted due large area of commitment of this damage that requires urgent intervention. Regarding Tendency, a score 6 is attributed knowing that the problem is in a situation of average progression.

From the application of the checklist of the GUT Matrix in this building it was possible to elaborate the graph of priorities, which is represented by Figure 6, where it is possible to verify that priority pathological manifestations, that must be treated first, are fissures and cracks, in this case, in the main altar of the church, because it presents the highest scores, 384 scores, and represents a high priority damage, according to the descriptions in Tables 1, 2 and 3 of Section 2.

Second, in the order of priorities, it is the disintegration of lining elements with a total of 216 scores, being framed as an average damage. In the third position are the detachments of coating with 108 scores, being also framed in the degree of average damage. Humidity stains and atmospheric stains, both with 54 scores, are also identified as average damage. The damage with lowest severity, which is in the last position of the order of priorities, is mold /mildew, with 9 scores and low damage.

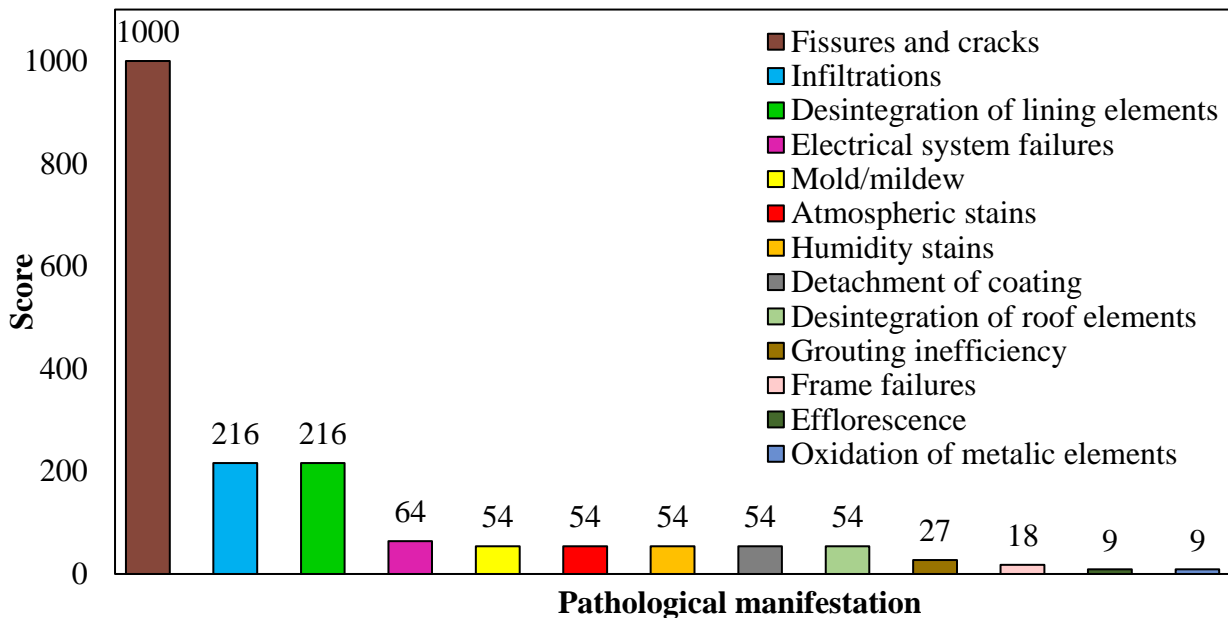
Figure 9. Priority graphic of the Nossa Senhora das Dores Church.

The data obtained from the application of the GUT Matrix in this building were organized in the priority graph shown in Figure 9, where it is verified that the pathological manifestation of highest priority is the crack in the central arch of the main nave, with a total of 1000 scores, which classifies it as a total damage, that is, of extreme gravity, urgency of solution and fast tendency of evolution. In addition, the difference between this damage and the two other (infiltration and disintegration of lining elements, both with 216 scores each) is very high, that corresponds to 784 scores, which show the severity of this crack.

Four pathological manifestations presented the same scores (54 scores): mold/ mildew, atmospheric stains, humidity stains, detachment of coating, which evidences pathological manifestations of average damage. The damages: grouting inefficiency (27 scores), frame failure (18 scores), efflorescence (9 scores) and oxidation of metallic elements (9 scores) correspond to category of low potential damages, the latter two occupying the final position of the order of prioritization. This building presented the largest number of pathological manifestations and this fact is connected to the lack of maintenance of the structure, moreover this church is now interdicted. The existing

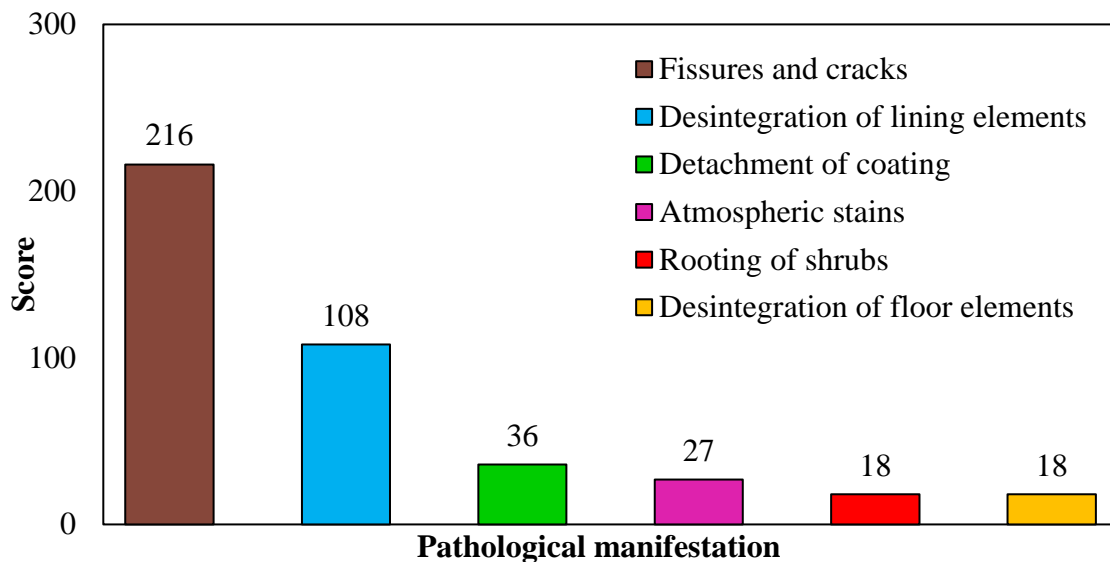
Figure 12. Priority graphic of the Menino Deus Church.

With the results of the checklist of GUT Matrix applied in this building, the graph of priorities was constructed and it is illustrated in Figure 12, where it is verified that the most prioritized pathological manifestation are the fissures, which can be observed in the upper opening of the front facade door (Figure 10) and also in an internal wall of the left lateral facade (Figure 11 (a)). The scores of this anomaly corresponds to 216 and are obtained by applying to the Severity, Urgency and Tendency 6 scores per each one, being therefore an average priority damage. In second position is the detachment of coating that presents a total of 108 scores, being also an average damage. In third and fourth positions are the disaggregation of lining elements and atmospheric stains, with 36 and 27 scores each one, being classified as average and low damage, respectively. In the final positions in the order of priorities, are the rooting of shrubs and the disintegration of floor elements, with 18 scores each, classified as low damage.

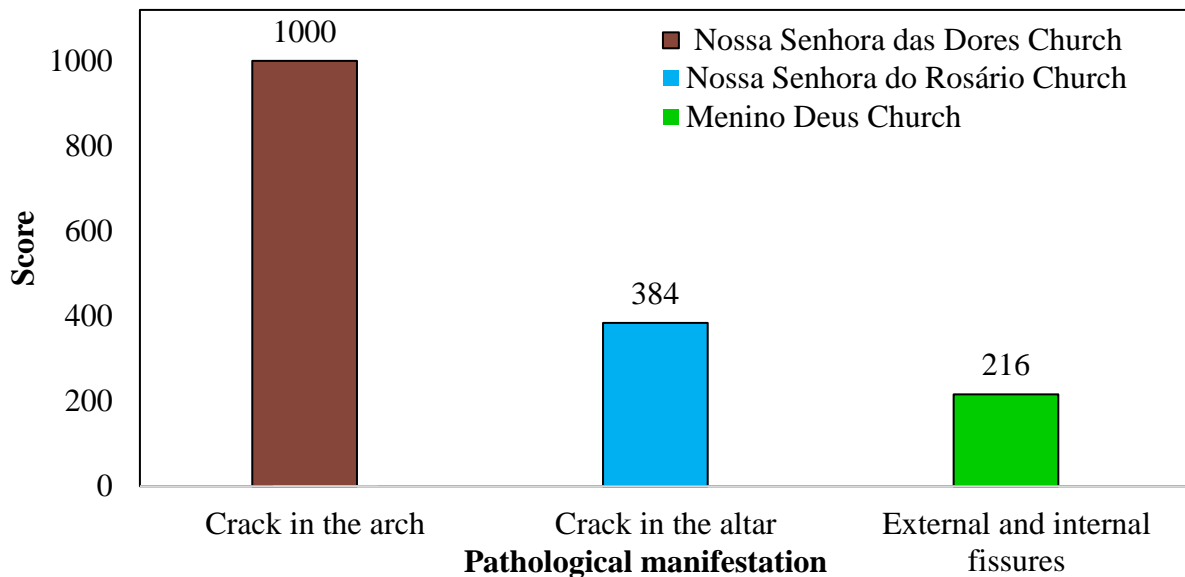
Figure 13. Comparative graphic between the most severe pathological manifestations for each church.

By the comparative analysis of the pathological manifestations listed in first position for each church and having as parameter its total score, among the three buildings studied, the Nossa Senhora das Dores Church presented the most severe damage with a total of 1000 scores for the crack in the central arch of the main nave. The second most severe was the Nossa Senhora do Rosário Church with a total of 384 scores also for a crack in the main altar. And finally, the third most severe damages were the fissures present in the main facade near the opening of the upper window, in the lower part of one of the columns of a tower and in walls of the internal part of the Menino Deus Church with a total of 216 scores. Figure 13 shows the comparison between the most severe damages of these churches.
