Engineering Failure Analysis 10 (2003) 423–429

Fracture analysis of a flow control device used in the petrochemical industry

This paper presents a service failure analysis of a steel control device assembled in a petrochemical industry division which resulted in a great fire. The purpose of this analysis was the determination of the reasons that caused fractures in the fixation screws of the body/cover of the valve during operation. The failure caused the leakage of hydrogen (H₂) and sulfide gas (H₂S), being responsible for an accident in Fortaleza, Brazil. Techniques such as visual inspection, electronic microscopy, optical microscopy, determination of mechanical properties, design analysis by computational simulation and spectrometry were used in this investigation. Several factors influenced the failure mechanism, such as: design failure, environmental cracking, device components out of fatigue and fracture specifications.

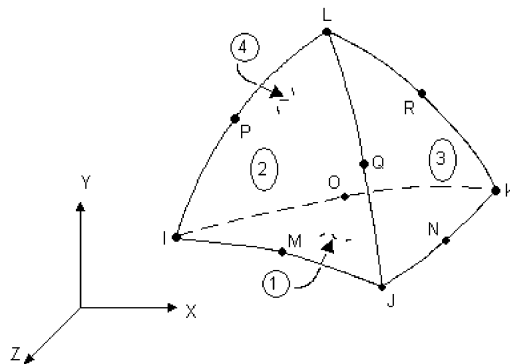
Fig. 4. SOLID92 (tetrahedral solid).

For this analysis only one type of finite element, SOLID92 (tetrahedral SOLID), was used (see Fig. 4); that element shape is appropriate to model 3D structures and consisted of three degrees of freedom in each node and displacements at x, y, and z nodal positions.

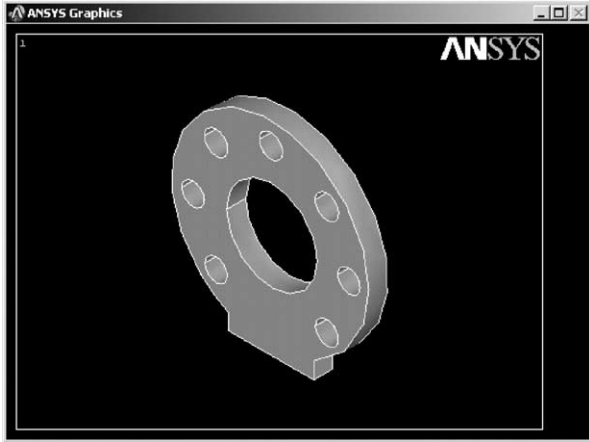
Fig. 5. Flange 3D geometry.

The 3D geometry of the flange was built in CAD software and then exported as an IGES file to be analyzed in the ANSYS program (see Fig. 5). The finite element mesh was generated automatically (see Fig. 6). The holes of the flange were constrained at x, y and z to simulate the fixation screws (see Fig. 7). Finally, the pressure loads were applied in a direction normal to the screws holes surface (see Fig. 7). The solution was done with the ANSYS linear solver. The Von Mises Stress contour plot was obtained with the ANSYS post-processor (see Fig. 8).
