Dynamic characterization of a heritage construction from 19th century

Caracterização dinâmica de uma edificação histórica do século XIX

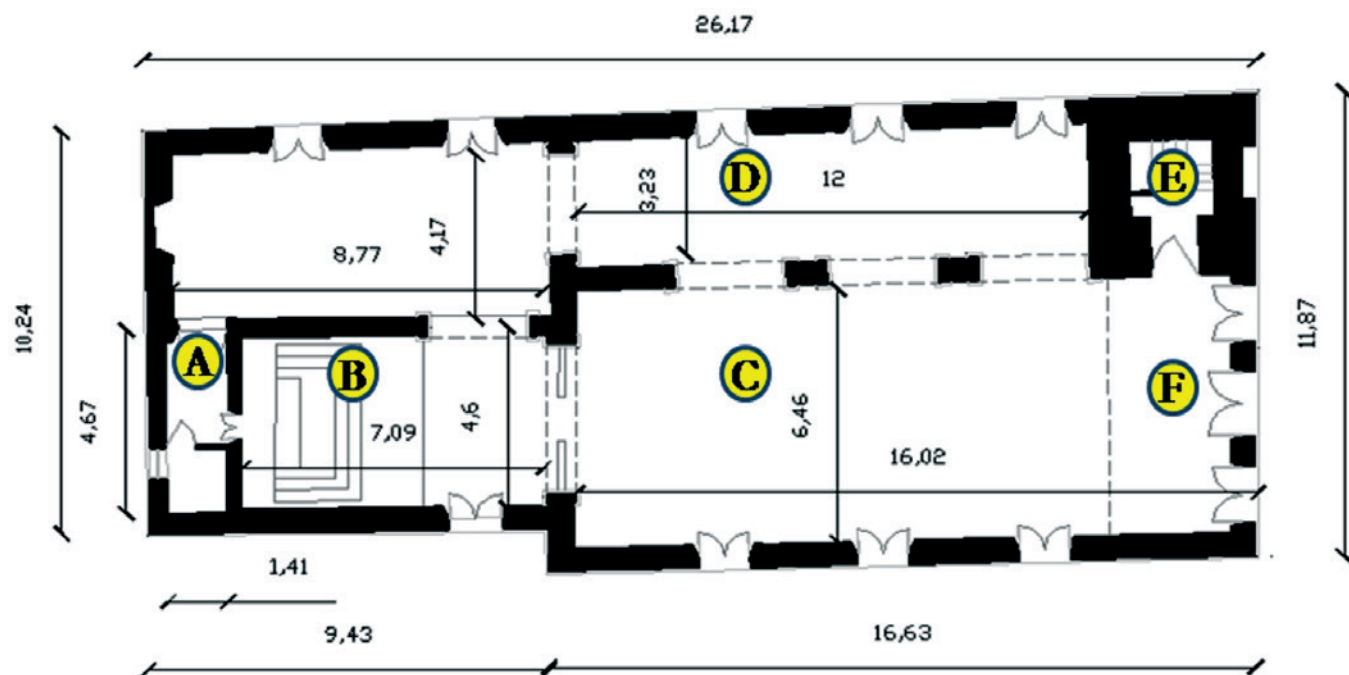
Figure 2
 Geometry of the Nossa Senhora das Dores's Church: (A) Sacristy; (B) Altar; (C) Central nave;
 (D) Lateral nave; (E) Lateral tower and (F) Floor [22, Adapted]

According to [11], the Nossa Senhora das Dores, dates from the decade of 1,810, and was built in the place where there was a set of old buildings located in the old Rua do Rio along the margins of the Acaraú River. It is not known when the church was built, but it is known that it already existed in 1,818. Its only and lateral tower does not follows the neoclassical rule of its elements of facades, because it was completed after 1,924. The Igreja das Dores was built in solid bricks masonry using local construction techniques. Its geometry (Figure 2) is characterized by one central nave of greater proportion (6.46x16.02m) and one lateral of smaller proportion (3.23x12.00m). In the same alignment of the central nave is located the altar, which is separated from this nave by one triumphal arch. After the altar there is a small sacristy and utilitarian dependencies of the Church. The access to the floor (choir) can be done by a staircase in the only lateral tower with 20.50 m of high.

Analyzing the Figures 13 and 14, can be inferred that the lateral left wall and the region of the central arcs, are the zones of the edification that are most requested in the modal shapes. For the lateral left wall, this fact may be related to non-continuity of the same, as it can be observed in the Figure 2, as this, a local modal shape was generated resulting in large modal

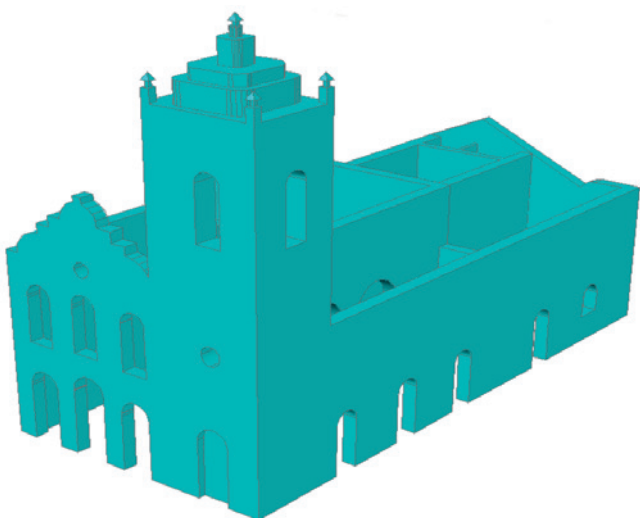
Figure 4
3D model of the Nossa Senhora das Dores's Church

For the creation of the 3D model of the Nossa Senhora das Dores Church, was done a consultation of the building plans, provided by IPHAN-CE in CAD format. In addition, was done a visit to the church, that allowed the validation of the constant measures in the geometric registers. Based on these registers and the visit, a 3D model of the church was built using the AutoCAD® commercial software (Figure 4), where is possible to see that the wooden ceiling, the ceramic tile roof and the frontal façade, were not modeled, as a way to simplify

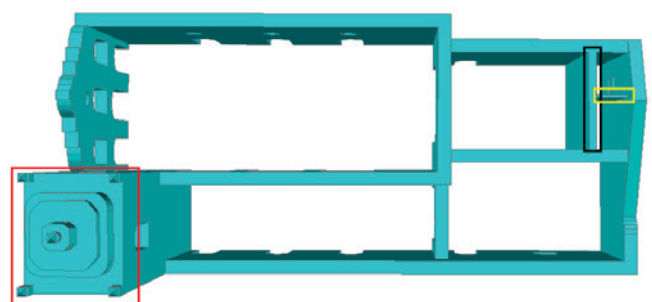
The ornamental details of facades and doors were simplified, the walls were modeled with a constant thickness of 60 cm, except the highlighted walls in Figure 5, where the black rectangle indicates the wall behind the altar with a thickness of 35

cm, the yellow rectangle indicates the wall of the bathroom door with a thickness of 15 cm and the red rectangle indicates the walls of the lateral tower that was modeled with a thickness of 105 cm. These measurements were obtained according to the existing geometric records and confirmed in the *in situ* inspection that was performed.

Figure 5
Details of wall thicknesses adopted in 3D Model of das Dores's Church

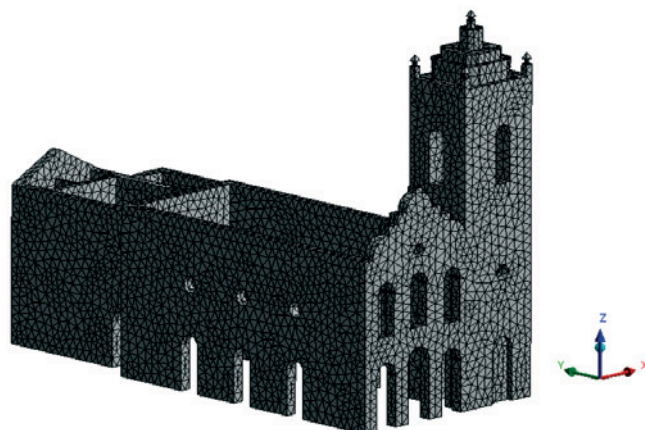
In the discretization of the numerical model in finite elements developed in the program Ansys® (version 17.1), was used a mesh of 500 mm side, it was generated 53,889 elements and 93,380 nodes. The element chosen was SOLID187, a tetrahedral element of 10 nodes with 3 degrees of freedom in each. This type of element is very flexible and compatible with irregular meshes and allows that curvilinear surfaces, arches, doors and windows, to be modeled more precisely without geometry losses. The Figure 6 shows the finite element mesh used.

Figure 6
Finite element mesh used in the model

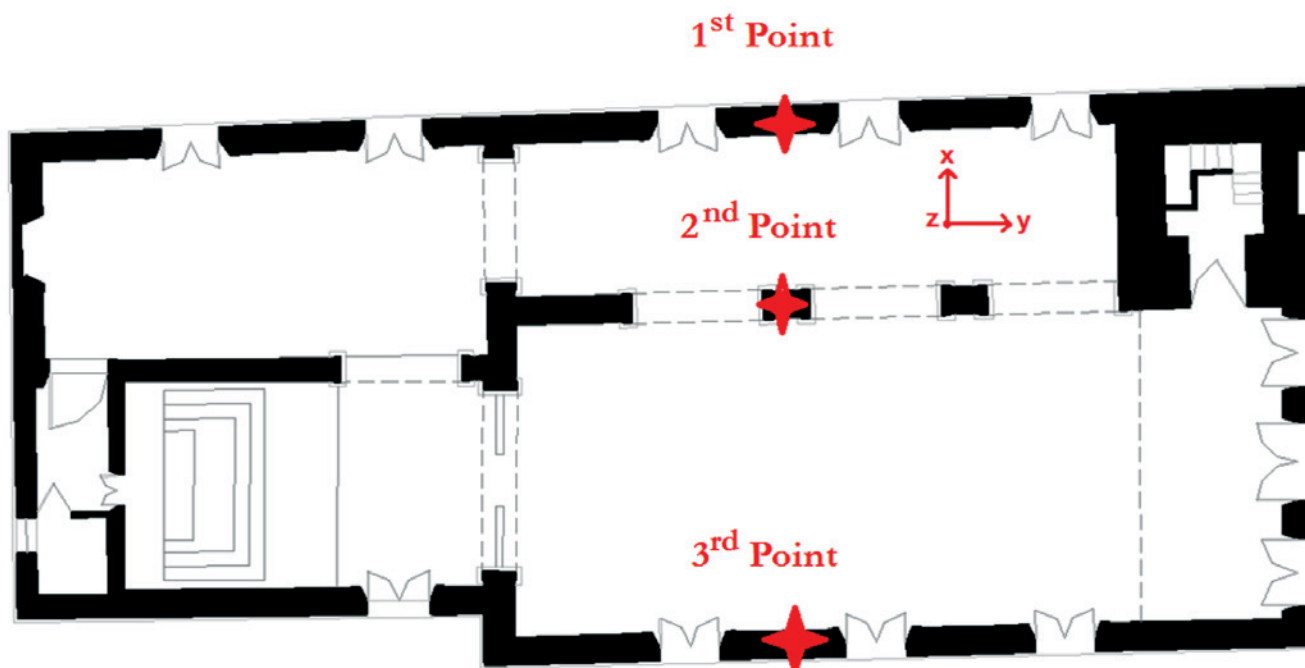
The equipment used in this test was a triaxial accelerometer of the piezoelectric type, with sampling frequency between 0 Hz and 100 Hz, configurable through a software developed in Labview by the Instituto de Telecomunicações de Aveiro, Portugal. The points where the accelerometer was positioned are indicated in Figure 7.

Figure 7
Location of the points of the building that was chosen for the environmental vibration test

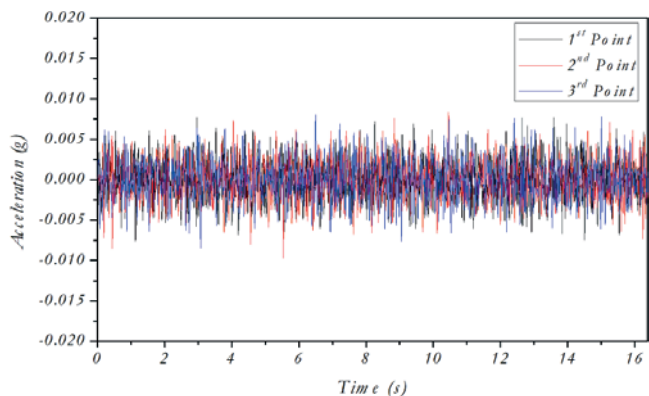
Figure 8
Accelerogram of 3 points on the X axis

The accelerograms collected in the test (Figure 8 and Figure 9)

were processed using the Fast Fourier Transform (TRF), using 16,384 points, since the TRF requires samples whose size is the entire power of 2, in this case $2^{14} = 16,384$. The points were spaced at 0.001 s time intervals, which totaled 16.384 s of signal and the noise effects on the frequency signals were filtered with *SeismoSignal*[®] software.

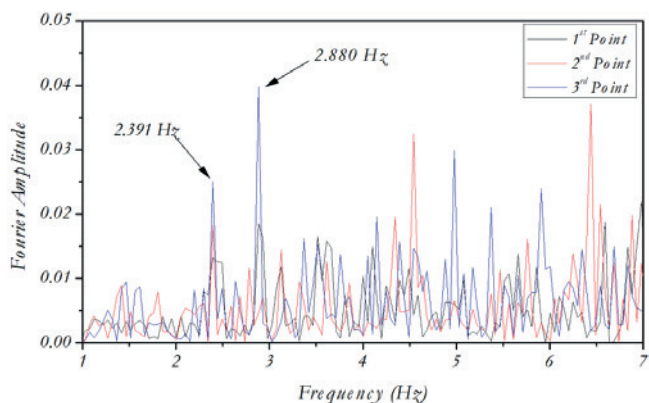
Figure 10
Fourier spectra in the X axis for the three points tested

axes (X and Y), in addition, the structure does not have pavements, so, there is no expressive participation of effective modal mass in the Z axis, that would lead to an increase in frequency. Applying the TRF to the accelerograms in X and Y axis, was possible to obtain the Fourier spectra in these two directions. Still in the preliminary modal analysis of the model, no frequencies lower than 1.50 Hz were found, therefore, for the building in study, a filter Lowpass and Bandpass from 1.00 Hz to 30.00 Hz was applied to the Fourier spectra to eliminate the external frequencies at this interval. It is further emphasized that the amplitude of the frequencies comprised between 0 Hz and 1.00 Hz before the application of the filter, were not greater than 0.01 Hz reason why the application of the filter is justified. With the application of the filter to the calculated Fourier spectra, the results obtained are shown in Figure 10, for the X direction and in Figure 11, for the Y direction. Is shown only the frequency range on the horizontal axis between 1 Hz and 7 Hz for a better visualization of the maximum amplitudes of each frequency and also because, the first three frequencies identified for the building are within this range, as indicated in the figures. By analyzing of the these two spectra, it can be inferred that the first 3 natural frequencies of the building are between 2.00 Hz and 4.00 Hz. Considering the frequencies with the highest

values of amplitude in relation to each axis, the first fundamental frequency of the building is 2.391 Hz in relation to the X axis, the second is 2.880 Hz also in the X direction, since the amplitude of the first two peaks in the X direction is greater than in the Y direction. The third natural frequency was obtained on the Y axis in the third peak of the spectrum of the Figure 11, whose value is 3.125 Hz, because in this direction its amplitude much larger than the third peak of the spectrum of Figure 10. The values of the first three natural frequencies of the das Dore's Church are indicates in Table 2. Only the first three natural frequencies of the das Dore's Church are identified, because these were considered sufficient for the calibration of the model in finite elements, in addition, the most important of all is the first, because it has the longest period.

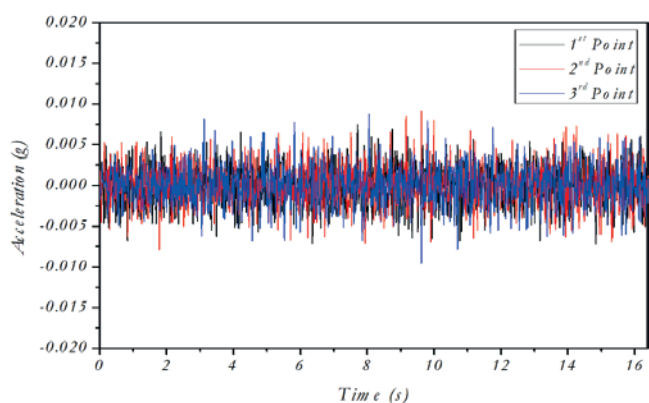
Figure 9
Accelerogram of 3 points on the Y axis

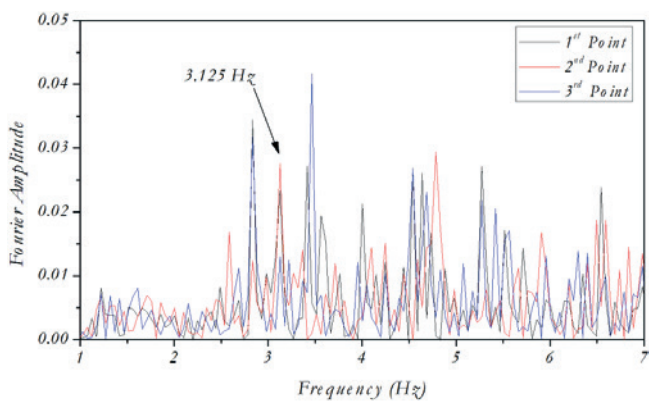
Figure 11
Fourier spectra in the Y axis for the three points tested

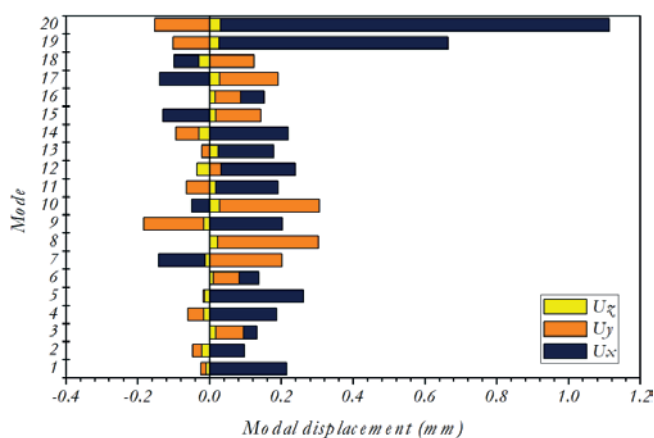
The Y direction also shows significant mass participation, more than 50% of the total mass of the church. The direction Z is the direction that presented the lowest percentages of modal participation, which indicates a tendency to obtain values of very low displacements in this axis, almost null. And it is precisely what is observed in Figure 12, where all the values of the directional displacements in each of the three axes are indicated.

The displacements shown in the negative direction of the horizontal axis indicate that the structure has moved in the negative direction of the reference axis system adopted in the analysis. The most expressive directional displacements are in the X direction, while the least expressive are found in the Z direction.

Figure 12
Comparison between the modal directional displacements of each mode

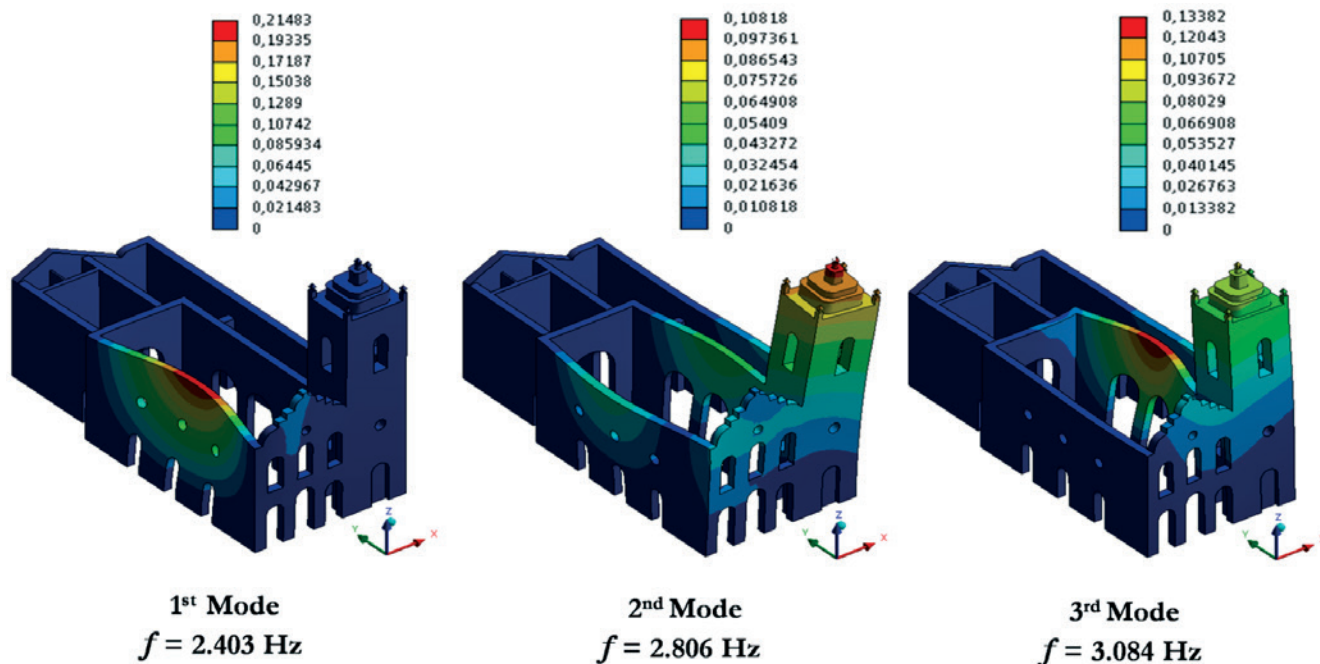
The first three modal shapes of the building are shown in Figure 13, where can be seen that the first mode is a local mode and presents flexion of the lateral left wall, that is the part of the structure that presents the biggest value of modal deformation, 0.215 mm, indicated by the red color of this figure. The second and third modal shapes are also flexion modes in the X direction, were in the second mode it is observed that the biggest modal displacement occurs at the top of the lateral tower; 0.108 mm. In the third mode, the biggest modal displacement occurs in the arcs that separate the two nave, which is 0.133 mm.

Figure 13
Three first modal shapes of the das Dores's Church

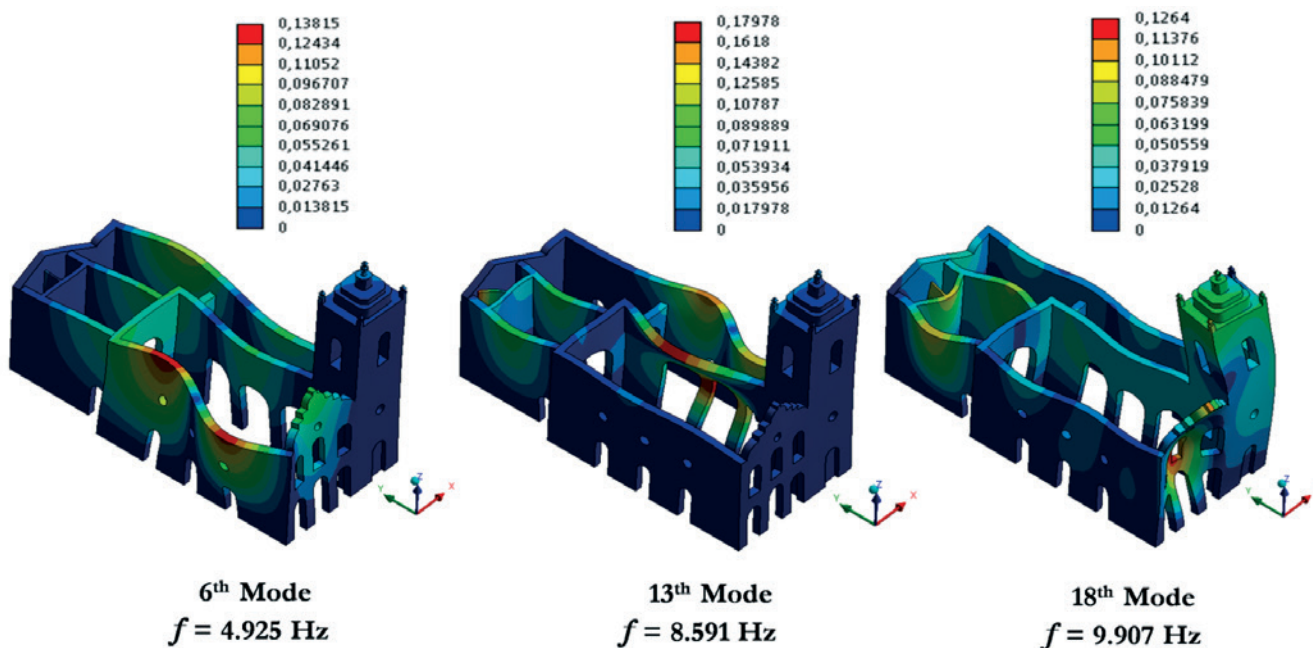
In Figure 14, are indicated the modal shapes that excite the major number of parts of the building, that is the global modes, were the 6th Mode and the 13th Mode, are flexion modes while that the 18th Mode is a torsion mode, that can be observed in the lateral tower.

Figure 14
Modal shapes with larger parts of the building excited
